ICE RIDGING INFORMATION FOR DECISION MAKING IN SHIPPING OPERATIONS

EM ice thickness measurements during 2005 IRIS field campaign

March 07 to March 18, 2005

IRIS Deliverable 30

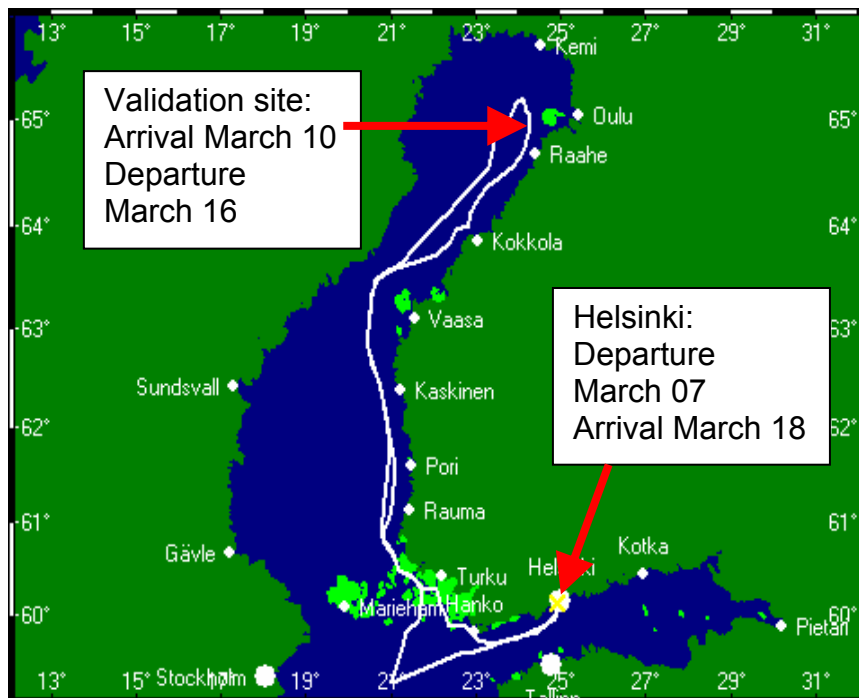
Figure 1: Map of the Baltic Sea, showing the operation area of RV Aranda during the IRIS 2005 cruise.

RV Aranda served as a base for the expedition. The ship left Helsinki on March 7, and arrived back on March 18. Between March 10 and 16, the ship was anchored in the fast ice west of the island Hailuoto in the Bay of Bothnia (Fig. 1). Aranda was used as a base for the ground-measurements (drilling, surveying, DC electric measurements), as well as for the helicopter-borne EM thickness measurements. Due to the professionalism and carefulness of the Helitour helicopter crew, take-off and landing the EM bird was very feasible, despite the small helicopter deck of RV Aranda (Fig. 2). The AWI team comprised Andi Pfaffling, Torge Martin, Stefan Hendricks, David Flinspach, and Christina Flechzig.

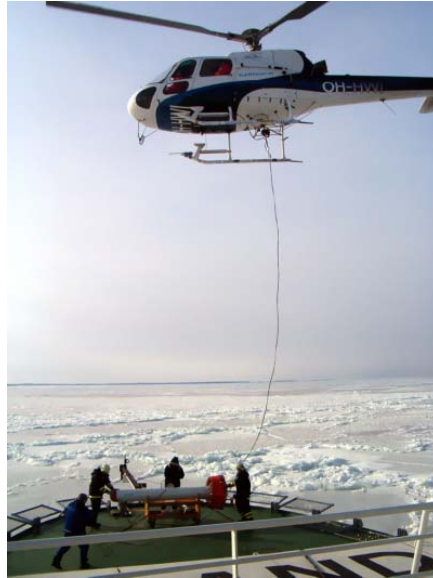
Figure 2: Landing the EM bird on its trolley on the small heli deck of RV Aranda proved very feasible due to the professionalism of the Helitour helicopter crew.

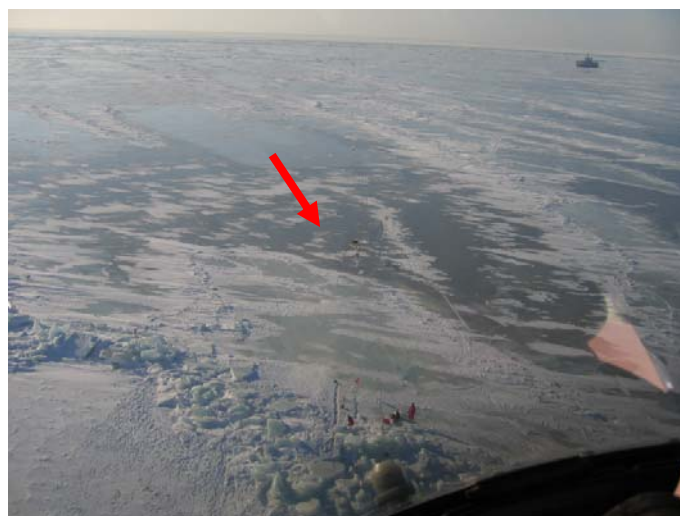
Figure 6: View along validation line from E to W. The ridge in the foreground is the prominent ridge at -100 m in Figure 8, and the red arrow points to the radar corner reflector 2 at 0 m (cf. Fig. 7).

The photograph on Figure 6 shows the eastern end of the validation line (cf. Fig. 7), and the western extend of the line in the background. The prominent ridge in the foreground is the rightmost ridge in the figures below, where also the DC electric measurements have been performed. In the upper right RV Aranda can be seen at here anchoring position in the fast ice.

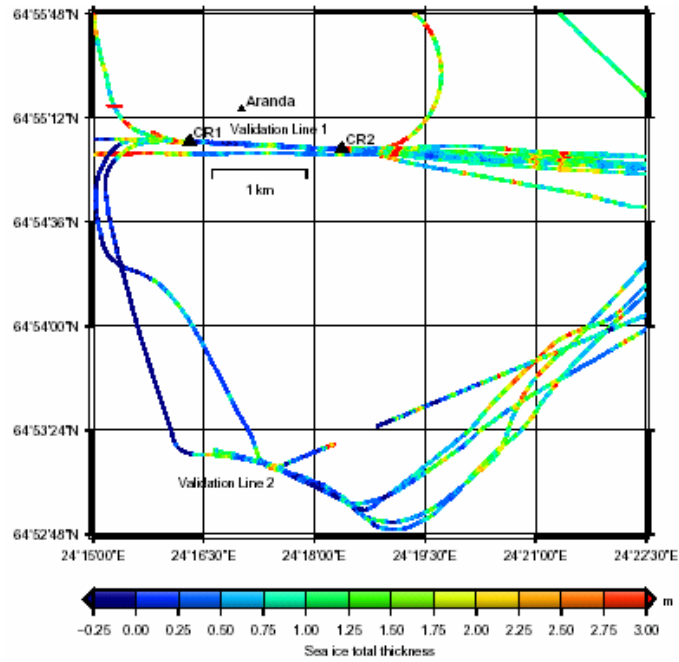
Figure 7: Overview of all ice thickness measurements performed along the validation line (cf. Fig. 8). CR1&2 mark the position of the radar corner reflectors.

Figure 7 summarizes all ice thickness measurements obtained during overflights of the validation line. All the main features are very well represented in the data:

1. Thick ice in the west, which was formed during a deformation event at the fast ice edge during the first days of the ice station.
2. Thin level ice on both ends of the validation line, with a prominent ridge in the center.
3. A large ridge just east of corner reflector 2
4. Some thicker fast ice in the east. However, note that these measurements could also be biased by the shallow water under the fast ice.

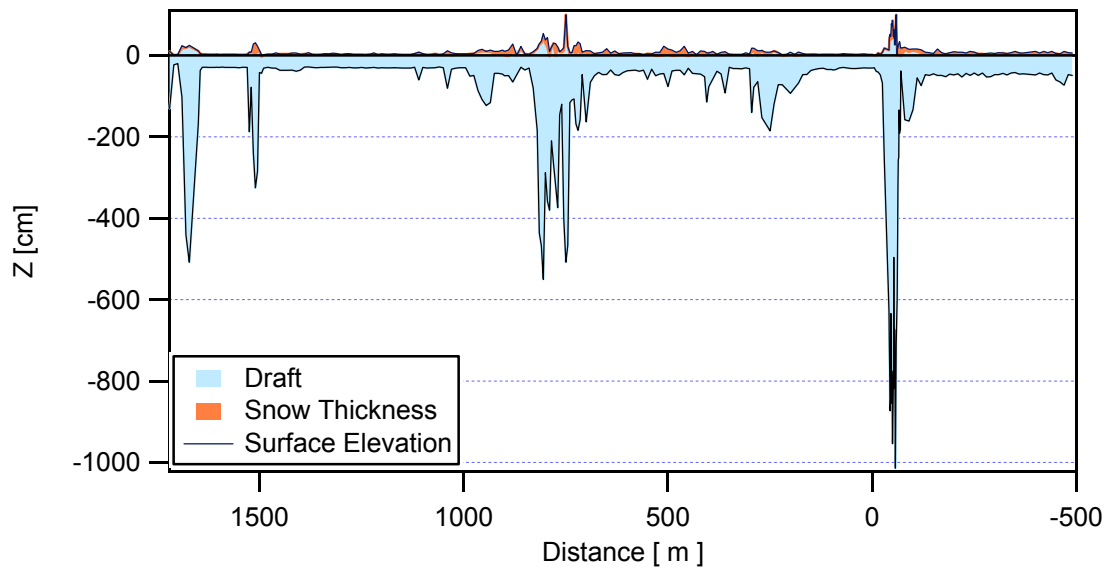
Figure 8: Ice thickness profile of the validation line. 0 m corresponds to the location of corner reflector 2, and west is towards the left of the figure.

All drill-hole results are summarized in the thickness profile in Figure 8 showing the real distribution of freeboard and draft along the line. A comparison of all HEM data with the drill-hole profile are shown in Figure 9. All HEM data have been averaged for the presentation. The EM and drill-hole data agree well over level ice, while the EM measurements underestimate the maximum keel depth considerably. See the discussion in the AWI IRIS report 2004 for more details (D20). The largest ridge with a thickness of 11 m was only 45 m wide. However, please note also that the EM data show some more deformation features which are missed by the one-dimensional profile of the drill-hole measurements. This is also visible in the thickness distributions shown in Figure 10. The mean drill-hole thickness was 1.42 ± 2.15 m, while the mean HEM thickness amounted to 1.10 ± 0.78 m. Note that the spacing of the drill-holes was smaller across the ridges.

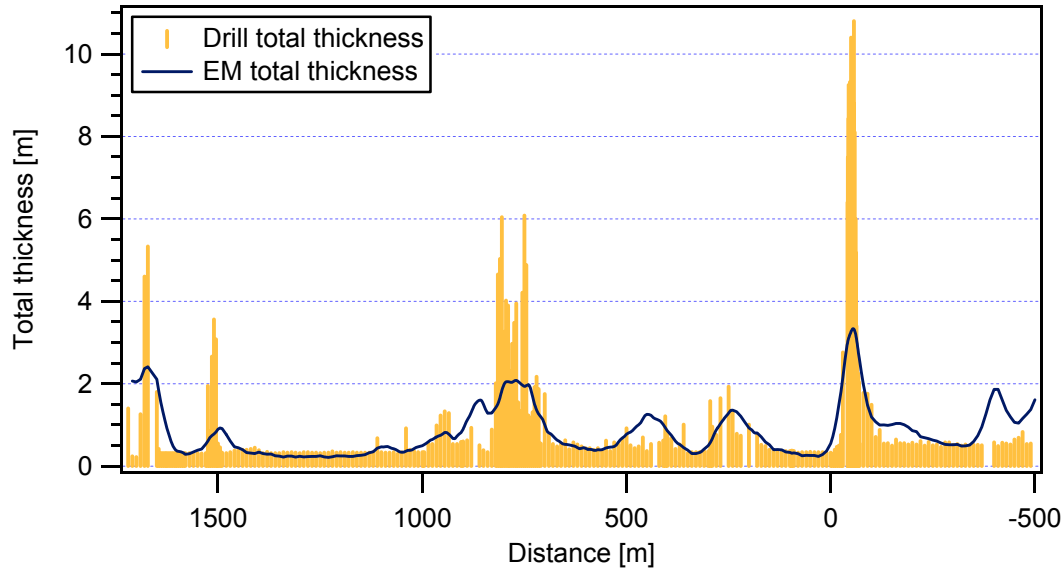
Figure 9: Comparison of the drill-hole thickness profile (Fig. 8) with the mean thickness of all HEM profiles along the validation line (Fig. 7).

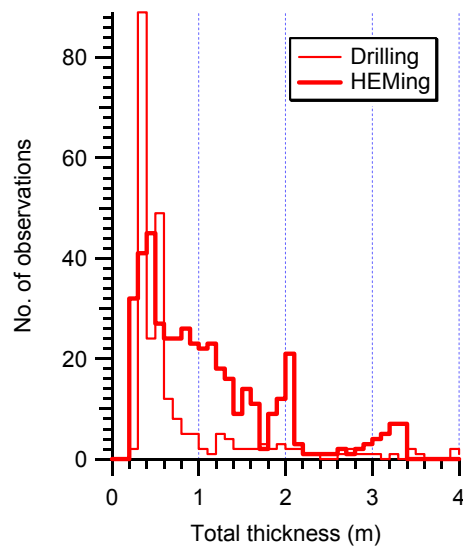
Figure 10: Comparison of the thickness distributions obtained by drilling and HEM sounding along the validation line (Fig. 9).

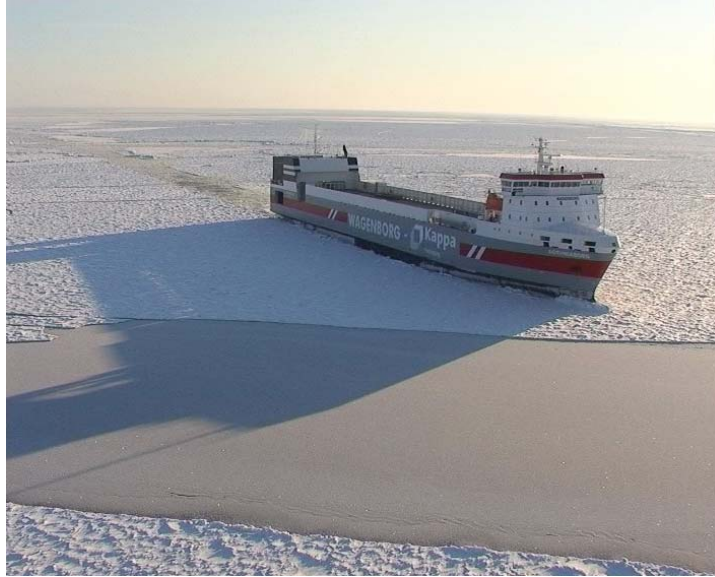
Figure 11: Photograph of MS Bothniaborg entering the thick ice zone where she almost got stuck.

The operation area of MS Bothniaborg in the western Bay of Bothnia was profiled on March 15 and 16. On March 15, we were able to survey the ice just in front of the ship before it passed along (Fig. 11). The photograph shows the ship when it just entered a region of thicker ice leading almost to a full stop of the ship. HEM thickness data show that this corresponded to a zone where ice thickness increased from an average of 0.6 m to 1.3 m (Fig. 12). The thick ice was formed by former rafting of the thinner ice.

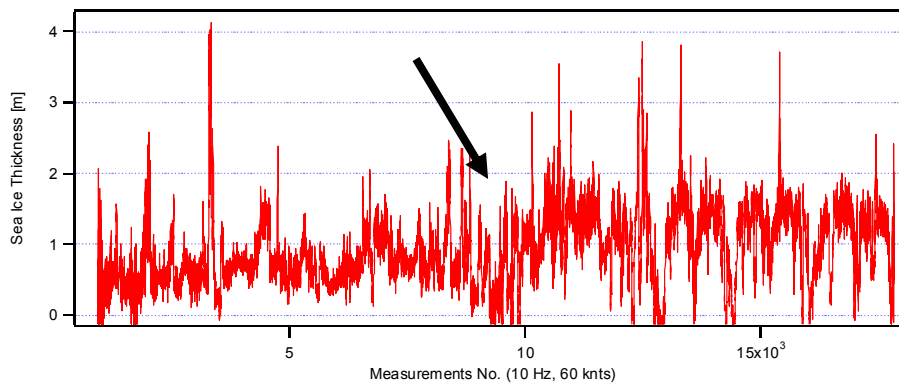
Figure 12: Thickness profile along track of MS Bothniaborg (file 200503151438.dat), showing the transition from thin to thick ice where the ship almost got stuck.

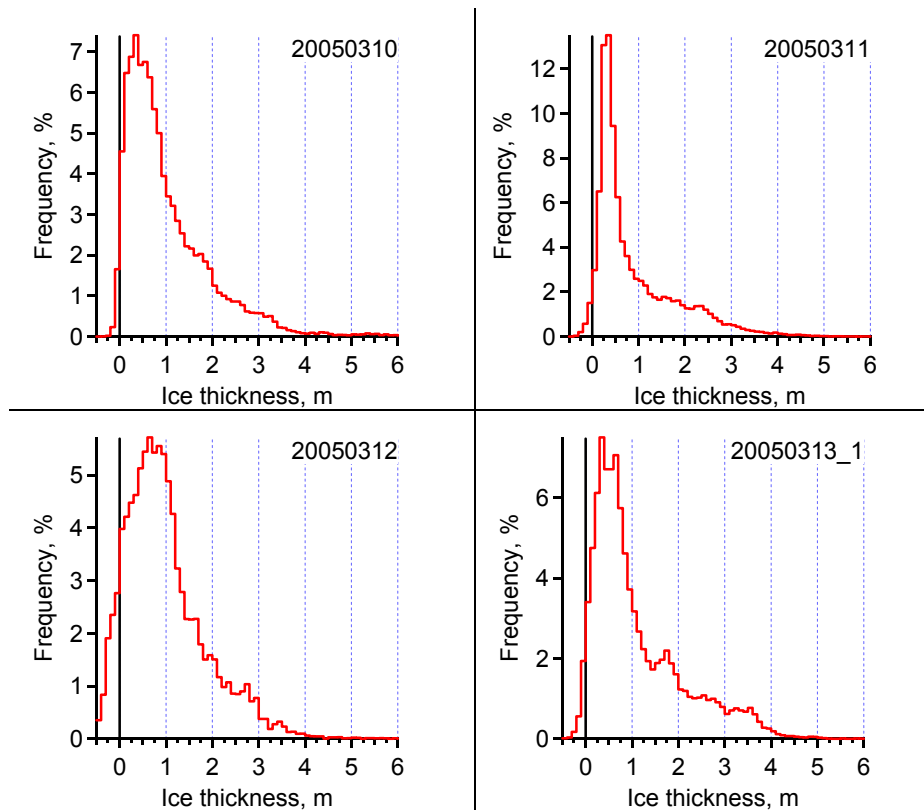
Figure 13: Thickness distributions of all IRIS 2005 flights (cf. Table 1).

Below, the results of each flight and the corresponding thickness distribution are summarized (Table 1, Fig. 13). Note that these also often comprise flights over the validation line, i.e. from a different region than the main study region of each flight. Therefore, if the users of the data are interested in special regions, they should look at the profile maps below to see the spatial distribution of flights, and need to extract the data of interest from the data files.
