New insights into coastal erosion rates along the Yukon coast, Canada

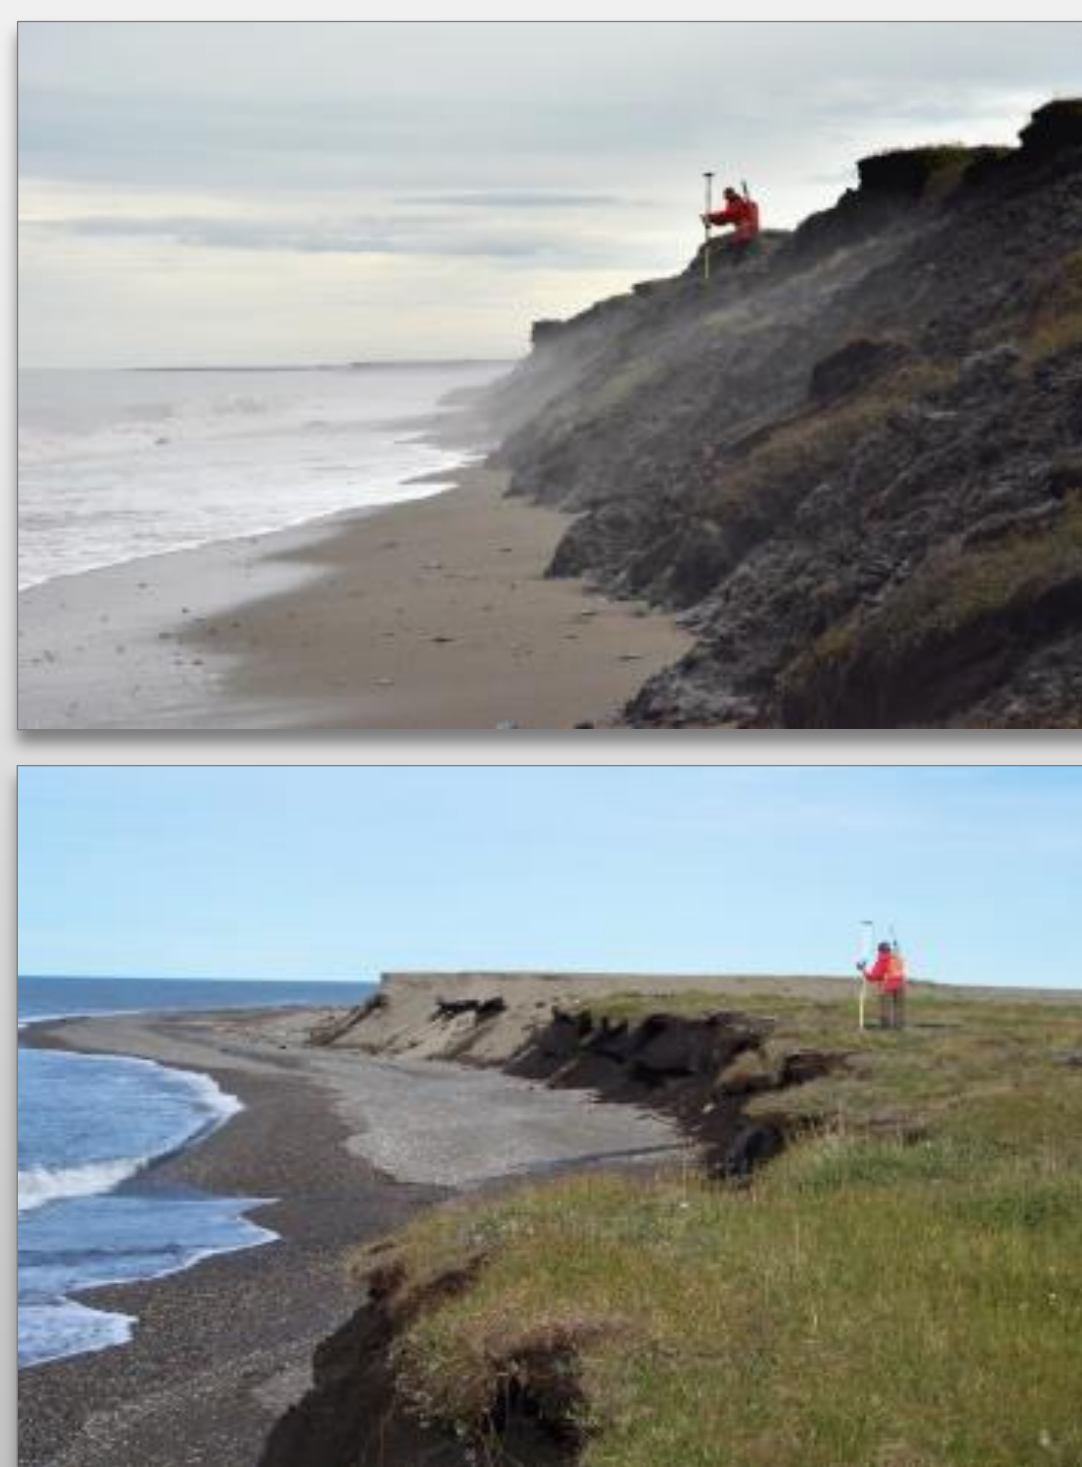
Figure 3: RTK-GPS measurements taken along the border site (top) and the Komakuk site (bottom) in 2012.

Geomorphology: Yukon Coastal Plain, mainly composed of marine and estuarine deposits, flat tundra with incised stream valleys, continuous permafrost, mainly narrow beaches backed by up to 11 m high gently sloping to overhanging cliffs (Fig. 3).

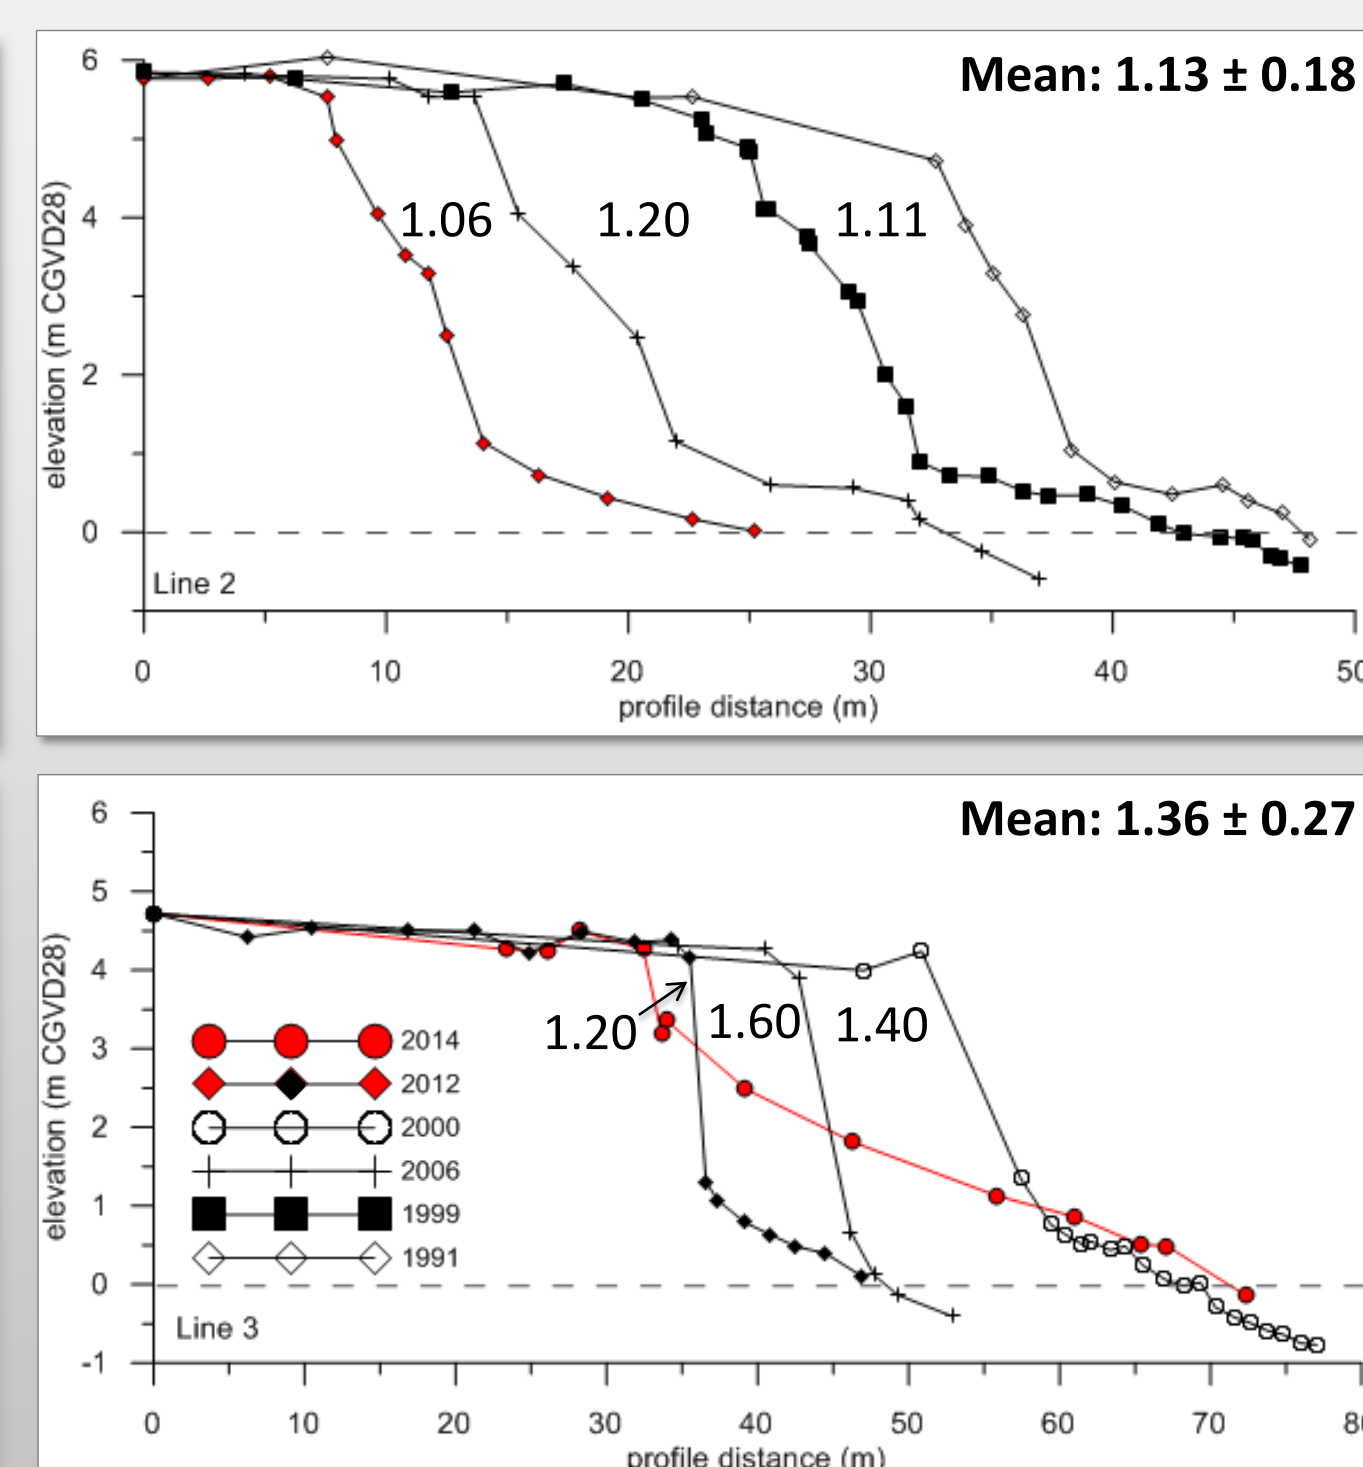
Figure 4: Visualization of the evolution of profile no. 2 at the Border site (top) and profile no. 3 at the Komakuk site (bottom). Note that numbers btw. the profile lines and the listed mean values in the corners of each graph are the respective erosion rates [m/a] for the whole site.

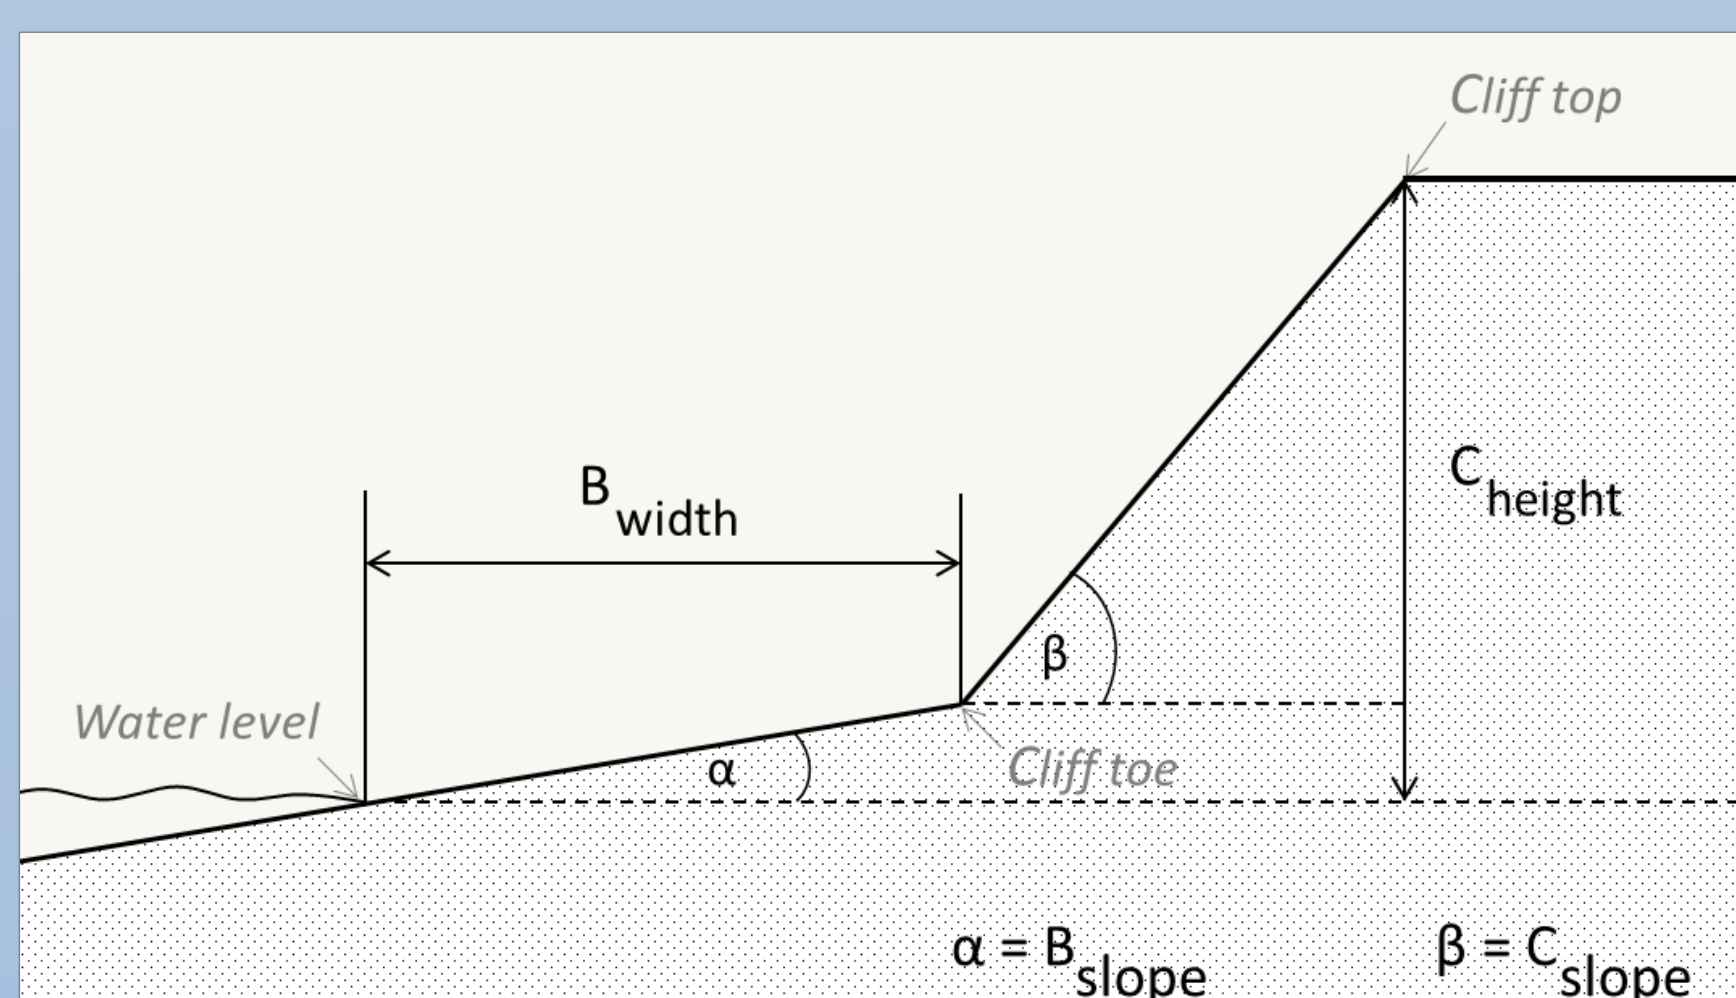
Figure 6: Schematic shoreface profile with the calculated parameters: beach width (B_{width}), beach slope (B_{slope}), cliff height (C_{height}) and cliff slope (C_{slope}).
