CRUISE REPORT

ARCTIC AND ANTARCTIC SEA ICE - THICKNESS VARIABILITY AND CHANGE,
ICE LOADS, AND NAVIGABILITY

Le Commandant Charcot, Cruise No. CC110823, 2023-08-11 - 2023-08-26,
Longyearbyen (Svalbard) – Longyearbyen (Svalbard)

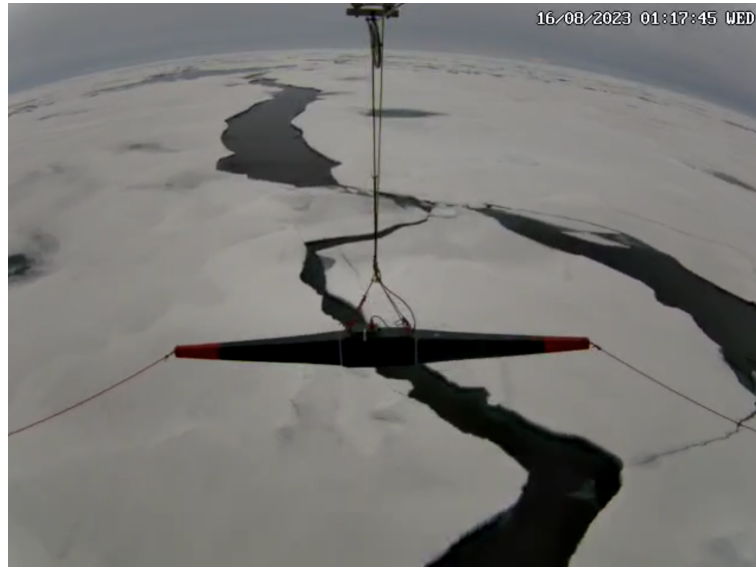
Figure 6. View of the front camera

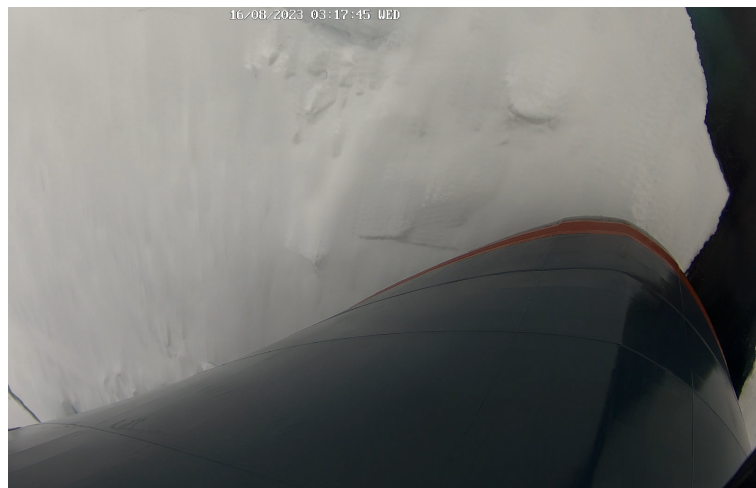
Figure 7. View of the backward facing camera 16/08/2023 01:17:45 UTC
